Manhole Inspection Summary

Manhole # S31SS_025MH

Insp Date: **5/9/07 12:05 PM**

Location Address: **2701 CRESMONT AVE**

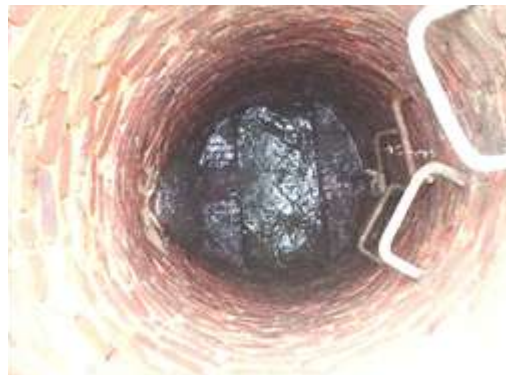
Top View

Corroded steps. Bench debris.

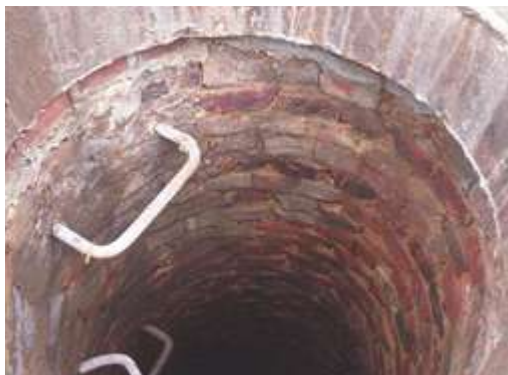
Defect

Frame leaks. Adjustment and Corbel deterioration and infiltration. Barrel infiltration - other side.

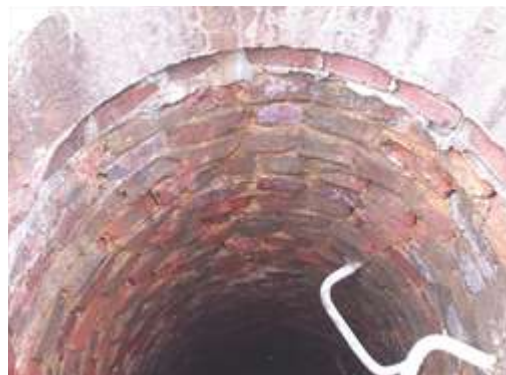
Defect

Frame leaks. Adjustment and Corbel deterioration and infiltration. Barrel infiltration.

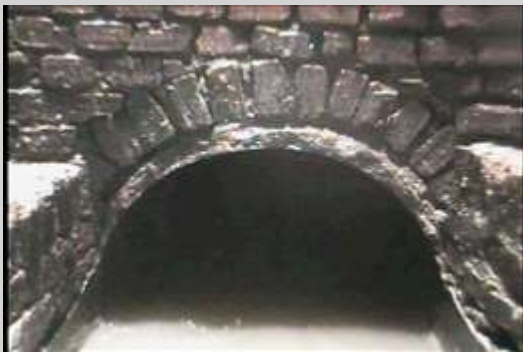
24 in. Circular Gravity Sewer Pipe Out @ 12 O'Clock

Barrel deterioration and infiltration.

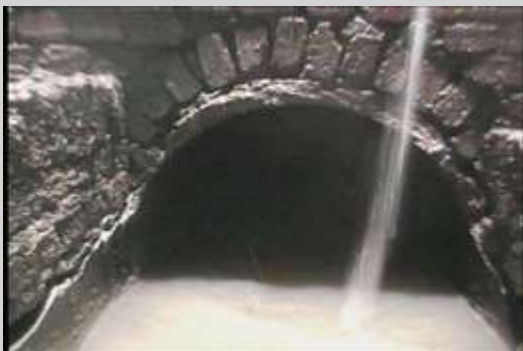
24 in. Circular Gravity Sewer Pipe In @ 6 O'Clock

Barrel infiltration (Active). Barrel and Channel deterioration.

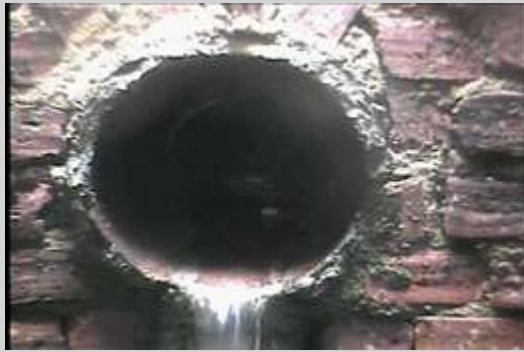
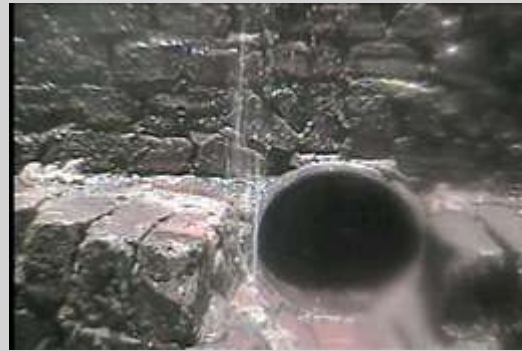
Barrel deterioration and infiltration. Bench and Channel deterioration.

Drop Condition: **Partly Clogged**
